Article

Evaluating Damaged Concrete Depth in Reinforced Concrete Structures under Different Fire Exposure Times by Means of NDT and DT Techniques

ENGINEERING JOURNAL Volume 21 Issue 7

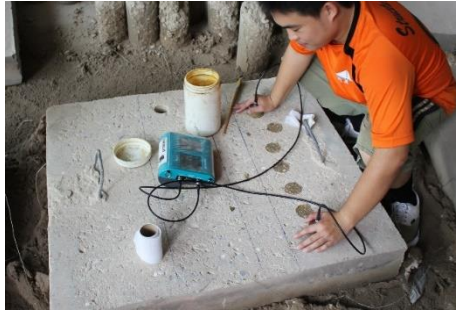
Fig. 5. UPV test on fire-damaged slabs.

In this experiment, the UPV test was performed with a frequency of 54 kHz and the measured positions were marked by lines with intervals of 100 mm. Data were collected both forwards and backwards in each line (Fig. 5).

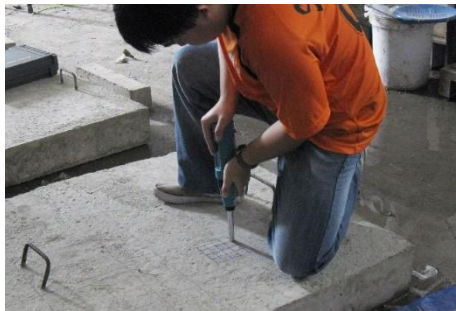
Fig. 6. Schmidt rebound hammer test.

Another NDT method, the Schmidt Rebound Hammer, was performed on the fire-damaged surface to determine the surface hardness of the concrete in each slab. The test was carried out on six locations of each slab and 16 testing points were recorded on each location (Fig. 6). This test was conducted based on standard ASTM C805 / C805M-13a [15].

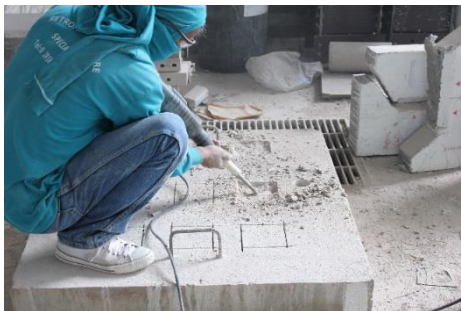
Fig. 8. Removing concrete via drilling machine.

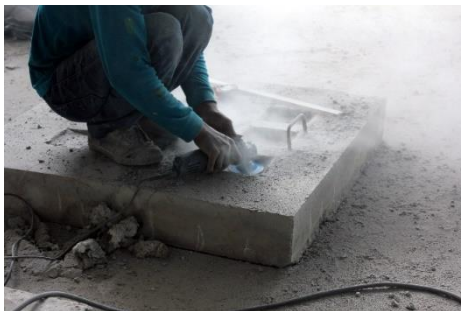
Fig. 9. Smoothing the surface of concrete.

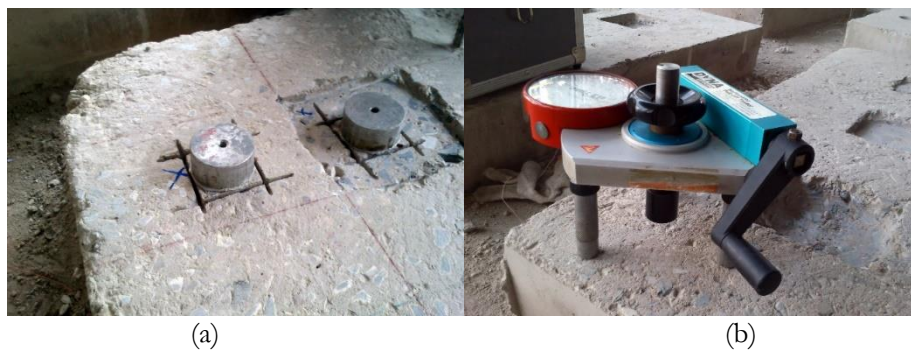
Fig. 10. Installing pull-off test: (a) the steel disk; (b) the tensile loading device.

This test was performed based on standard ASTM C1583-04 [19] to evaluate the tensile strength at three depth levels of 10, 20 and 30 mm on the exposure side. In each slab, nine positions were located and divided into three groups that corresponded with three depth levels (Fig. 7). Then, the concrete in each group was carefully removed using a drilling machine operated until the maximum level of its cutting depth, as shown in Fig. 8. All of the new surfaces after cutting were grinded to prepare for the pull-off test (Fig. 9). A 50 mm diameter circular steel disk was attached to the new surface by epoxy adhesive (Fig. 10). The force required to pull the disc from the concrete surface by hand-operated loading equipment was measured and calculated to obtain the tensile strength.

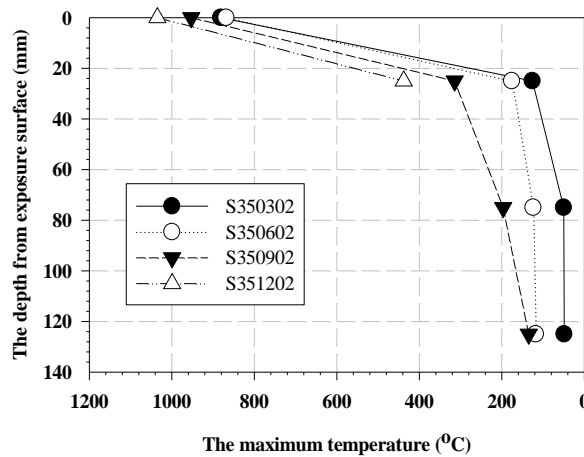
Fig. 12. The maximum temperature recorded at different depth levels for the 35 MPa slab.

The maximum temperature at the exposure surface and three other depth levels (25, 75, 125 mm) in each specimen are reported in Table 2. Moreover, the change of the highest temperature on the depth of concrete is represented in Fig. 11 and Fig. 12. Due to the breaking of thermocouples in the depths of 75 and 125 mm, the values of maximum temperature at these positions were not recorded in the case of slab S351202. However, it could be observed in all specimens that temperature generally reduced corresponding to increased depth from the exposure surface as concrete is a poor conductor of heat [5], due to its incombustible nature and its low thermal diffusivity, which guarantee a slow propagation of thermal transients within the structural members [20].

In all cases, the increase of fire exposure time led to the increase of temperature at every evaluating location. However, the increase became significant as the time surpassed 60 minutes. At the depth of 25 mm, the temperature increased 30°C as the fire exposure time reached 60 minutes compared with the heat increase at 30 minutes. Meanwhile, the heat increased more than 250°C as the time rose over 90 minutes in comparison with the heating time of 30 minutes. This change was observed in both series of 24 and 35 MPa concrete.

Regarding to the alteration of temperature on further depth, the heat dropped through concrete over 25 mm with a reduction of approximately 600°C. Nevertheless, the decrease became smaller at deeper levels.

Moreover, referring to the temperature profile in Fig. 11 and Fig. 12, the specimens that were heated for 90 and 120 minutes showed a temperature of over 300°C at a depth of 0 – 60 mm from exposure surface. When heating concrete above 300°C, the color of concrete can change [6]. Therefore, the observation of the depth of color change in coring test was appropriate with the temperature obtained.

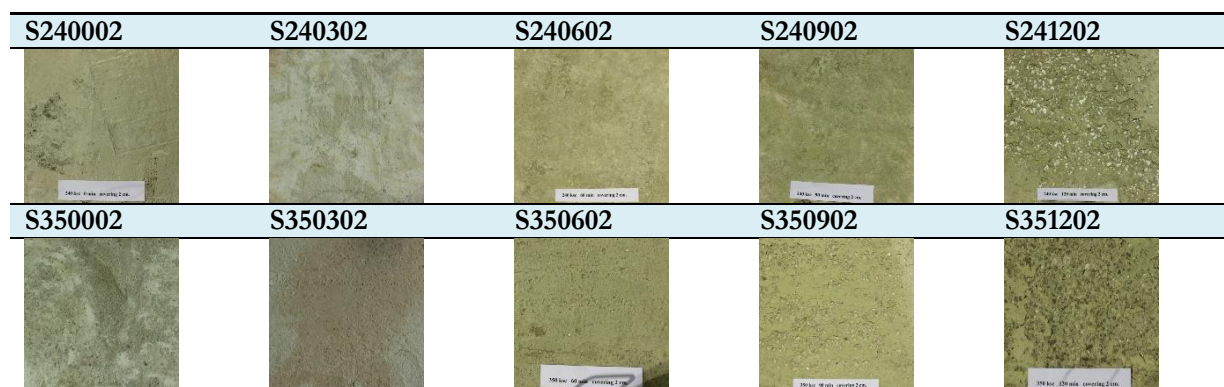
Table 3. The observation on fire exposed surface of specimens.

The assessment began with visual observation of color change, cracking and spalling of the concrete surface. It was observed that cracks appeared on exposure surface in all slabs and the spalling area was larger on specimens that had longer fire exposure times (Table 3). Based on the data from the thermocouples on the exposed surfaces, all of the specimens were heated to over 800°C. At this temperature, the cracks became very pronounced and increased extensively at 1000°C [9]. After exposure to the fire, the exposure surfaces showed a brighter color due to the limestone. At temperatures above 700°C, carbonate aggregate decomposes into CaO and CO₂ resulting in brighter colors due to the lime's whitish tint [21].

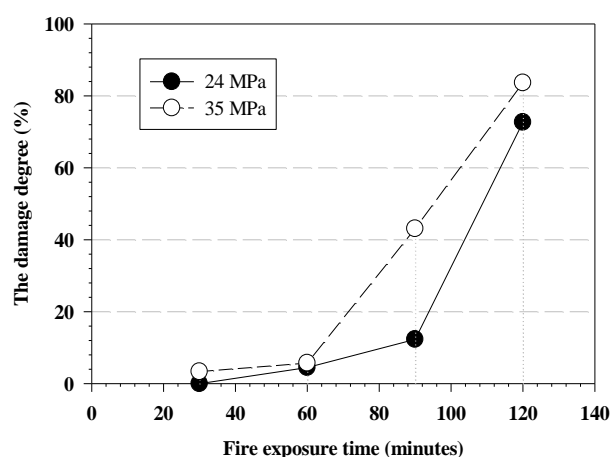
Fig. 13. The effect of fire exposure time to the damage degree.

The second visual inspection determines the degree of damage on the exposure surfaces using a transparent plastic plate as mentioned above. The area of spalling was reported (Table 4) and compared with the control specimens in order to estimate the change caused by high temperatures. Next, an evaluation on the effect of fire exposure time to the degree of damage were drawn in Fig. 13. The graph shows that the increase in fire exposure time led to a raise in the degree of damage on the concrete surface. The area of spalling was not much different in the slabs exposed to fire for 30 and 60 minutes. Obtained values were less than 6%, while the results from the other specimens were more than six times higher. A remarkable increase was recorded for the slabs exposed to fire for more than 90 minutes. This could be explained by the high

The longer exposure time, the more spalling was observed on concrete surface, especially for samples with more than 90 minutes of exposure time. Meanwhile, the slabs with a heating time of 30 minutes exhibited the lowest values of damage. Another observation showed that the 35 MPa slabs exhibited a higher degree of damage than the 24 MPa slabs in all cases of exposure time. It is possible that the higher concrete grade specimens could be denser and therefore this might stop the water vapor inside the concrete from escaping from the concrete mass, which increases the susceptibility of spalling under fire conditions [22].

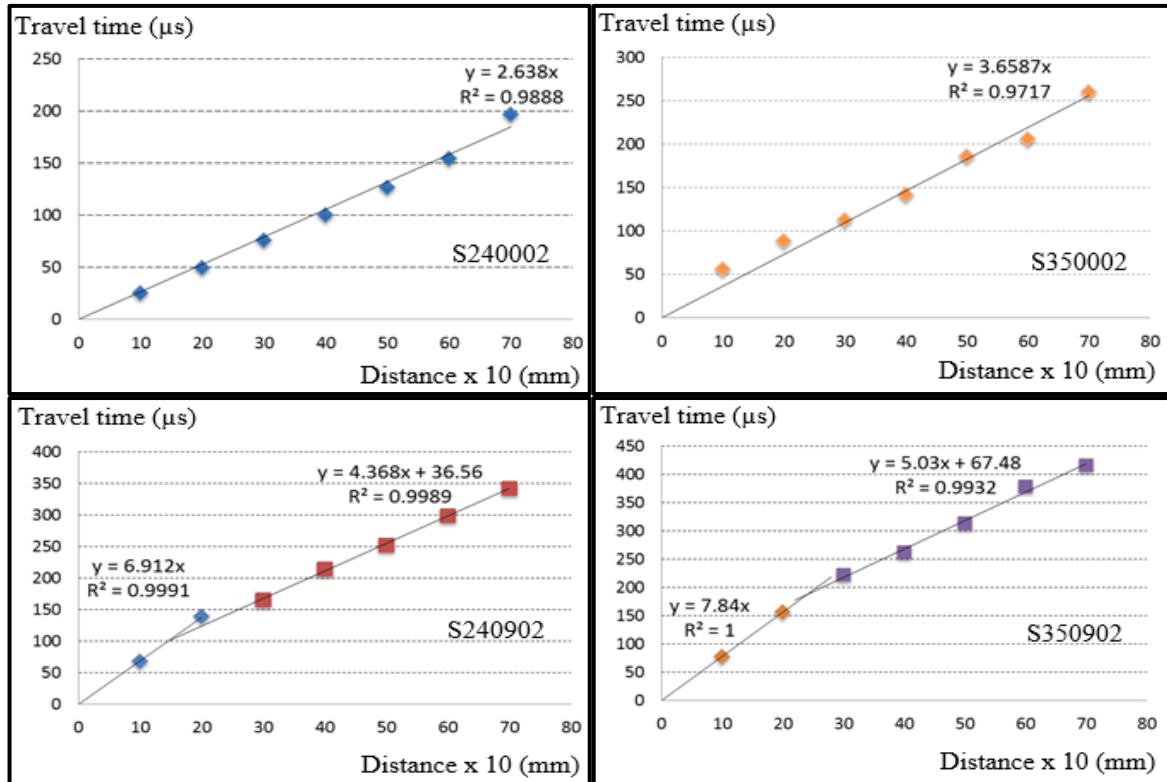
Fig. 14. Results of the UPV test.

The results from the UPV test showed that the intersection of the straight lines, corresponding with two paths as mentioned above, can be observed for specimens S240902 and S350902 as shown in Fig. 14. Therefore, the depths of fire-damaged layers calculated using Eq. (2) were 34.1 mm (S230902) and 56.1 mm

(S350902). In contrast, only a straight line was observed in the graphs of control specimens (S240002 and S350002) since there were not damaged concrete layers in these cases (Fig. 14). In the other slabs, the intersection between the straight lines matching with two wave paths was not clearly observed. Consequently, values of the damaged concrete depth were not calculated for the slabs exposed to fire for 30, 60 and 120 minutes.

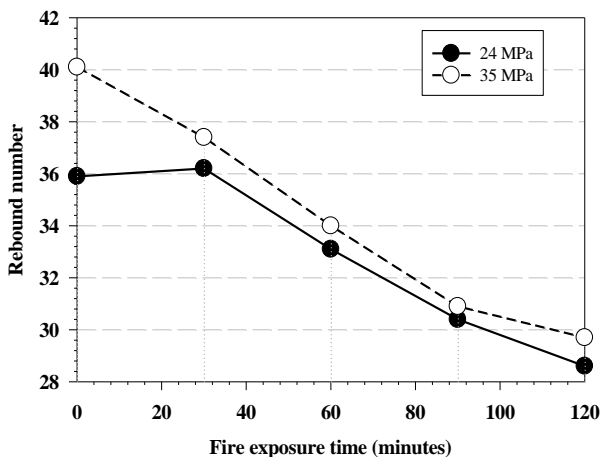
Fig. 15. The correlation between rebound number and fire exposure time.

After testing by UPV, another situ technique (the Schmidt Rebound Hammer test) was used to determine the surface hardness of the concrete after fire exposure based on the rebound number recorded. The results of this test are reported in Table 5 and Fig. 15 in terms of the correlation between the rebound number and fire exposure time. In case of control specimens for the 24 and 35 MPa slabs, the values of the rebound number were 35.9 and 40.1. Based on the chart in Fig. 15, the rebound number in two series of slabs decreased when the heating time was longer than 30 minutes. The lowest values obtained for the rebound number were below 30 in the slabs with a fire exposure time of 120 minutes.

As a result, longer fire exposure times resulted in lower rebound numbers, indicating more decrease in the concrete strength. These results were compatible with visual observation as the specimens with a long heating time showed higher degrees of damage on the concrete surface. Moreover, Fig. 16 shows the remaining rebound number (in percentage) of heated slabs compared to the results of control specimens. The results from the 35 MPa slabs were lower than the values obtained from the 24 MPa slabs. This indicates that the hardness of the surface on the 35 MPa slabs is lower than the 24 MPa slabs after fire exposure, which is similar to the results of the degree of damaged observed on the surface of the slabs as mentioned above.

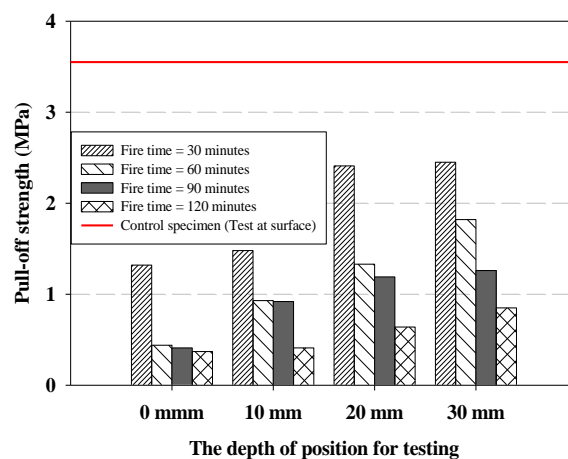
Fig. 19. The effect of fire exposure time to the pull-off strength in specimens of 35 MPa.

From those figures, it can be seen that the pull-off strengths achieved in specimens with fire exposure time of 30 minutes were significantly higher than the other specimens. This occurred at all of depth levels in both concrete grades. Therefore, the long exposure time (of more than 30 minutes) causes a serious decrease in tensile strength of concrete with the lowest strength value obtained after the longest heating time (120

minutes). In general, at each depth level, the pull-off strengths decreased corresponding with the increase in fire exposure time.

In addition, an increase in the pull-off strength at further depth levels was observed for each case of fire time. This is due to the decreased detrimental effect of fire at positions farther from the exposure surface as the temperature decreased at deeper concrete layers, as recorded by the thermocouple. Considering the 24 MPa specimens with a heating time of 30 minutes, the pull-off strength at the surface and a depth of 10 mm were lower than the results obtained from the control specimen. However, higher values were recorded at the depths of 20 and 30 mm. On the other hand, the pull-off strengths at all evaluated depths of 35 MPa slabs were lower than the value of control specimens.
