*Article*

## Stability of Runway Grooving Under Repeated Large Aircraft Loads

ENGINEERING JOURNAL Volume 16 Issue 4

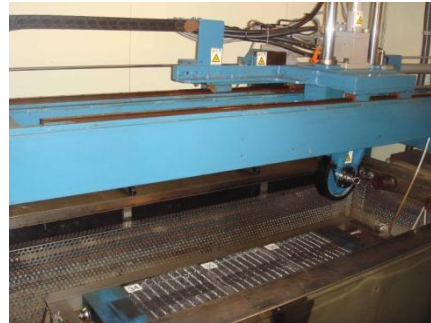
Fig. 1. Wheel tracking test machine.

The failure modes of grooving include clogging and edge defects. Of these defects, clogging of grooves is considered to greatly affect the drainage performance of runways, so the effect of load on clogging of grooves was focused on in this study. There are other causes that reduce the drainage performance, such as adhesion of aircraft tire rubber, but here clogging due to loading only is evaluated. To evaluate the clogging due to aircraft loads, repeated loading tests were carried out using the wheel tracking test machine shown in Fig. 1. This machine can apply loads equivalent to a large aircraft, and tests can be carried out at any temperature between 0 and 60°C. The test specimens used in the tests were produced based on “Method of Preparation of Test Specimens” for wheel tracking tests [8]. The grooving was carried out using a concrete cutter after outdoor exposure in the five exposure patterns: 0, 15, 30, 45, and 60 days. The shape of the groove is as shown in Fig. 2, a shape commonly used for airport pavements. The materials used in the test specimens were mixtures using straight asphalt 60/80, polymer modified asphalt type II (PMA II), and polymer modified asphalt type III (PMA III). Table 1 shows the quality standards prescribed for the PMA II and PMA III, and the property of these asphalts used in the tests. Also, wheel tracking tests were carried out on these asphalt mixtures, and dynamic stability was obtained for each material. The values of dynamic stability, the number of loadings to produce a 1mm rut in the asphalt mixture, were obtained at a test temperature of 60°C. The tests condition was set as described the reference [8] and the results are also shown in Table 1. Repeated loading tests were carried out at 20, 40, and 60°C, because the specimen temperature in the tests has a major effect on the deformation of asphalt mixtures. The contact pressure of the test wheel during loading was about 1.5MPa corresponding to a large aircraft such as the Airbus A380-800, based on the trends in the changes in forms of transport for passengers and cargo. The test wheel was controlled at a speed of 200mm/s to simulate the low travel speed at runway end. In the tests, the width and depth of the grooves were measured after 0, 20, 50, 100, 200, 500, 1000, 2000, and 5000 load repetitions on a test specimen. The test conditions are summarized in Table 2. The groove width and depth were measured using a laser displacement meter. The laser displacement meter was installed on a guide, and the guide was moved horizontally at the speed of 10mm/s measuring the displacement in the vertical

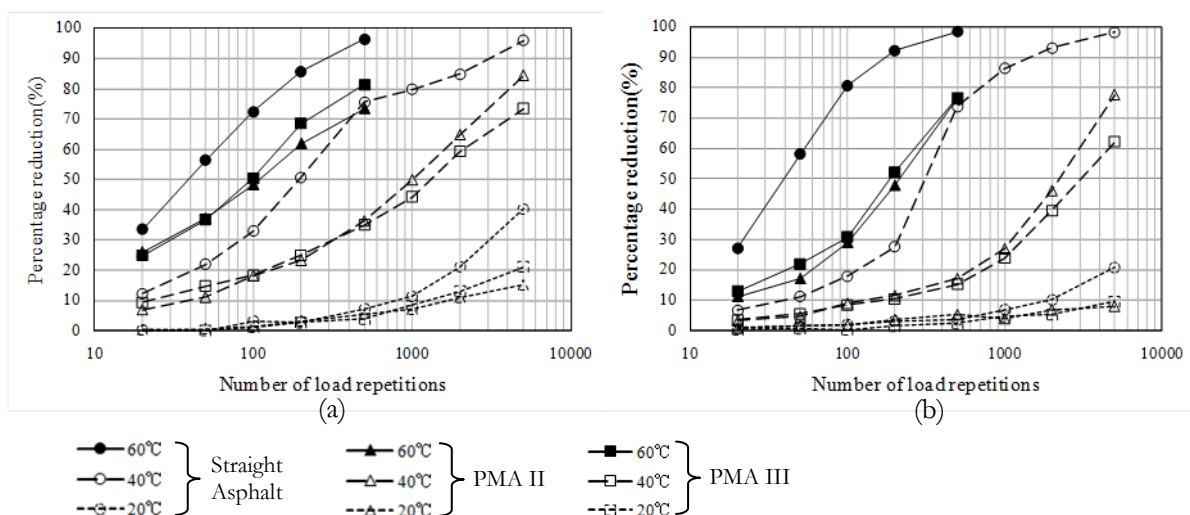
Fig. 4. Percentage reduction of the grooves for test temperatures.

Figure 3 shows the relationship between the number of load repetitions and the groove percentage reduction for each number of days of curing. Figure 3(a) and 3(b) show the percentage reduction of the groove width and depth. In the figure, the test temperature was 40°C, and the results are shown for asphalt mixtures using straight asphalt, PMA II, and PMA III. The groove percentage reduction is the average for three test specimens. From these figures it can be seen that for each asphalt mixture, there is no significant difference in the groove percentage reduction with the number of days of curing. In past studies, tests were carried out using the design loads for roads in Japan. Many of them suggested that there was an asphalt stability improvement effect by providing the number of days of curing. However, from the above test results, the effect of curing is relatively small when the loading is severe. There is a possibility that sufficient stability improvement effect will not be obtained. Figure 4 shows the relationship between the number of load repetitions and the groove percentage reduction for test temperatures of 20°C, 40°C, and 60°C. Test specimens used in the tests were cured for 15 days. When the loading tests were carried out at 20°C, there was only a small difference due to the three different types of asphalt mixtures in the initial stage of loading. On the other hand, when the tests were carried out at 40°C and 60°C, which are near or above the temperature for softening point of straight asphalt (47.0°C), it was found that the groove damage for the asphalt mixtures using straight asphalt was significantly larger compared with the asphalt mixtures using modified asphalt. This indicates that when the pavement temperature is high, the groove damage can be reduced by using modified asphalt. Comparing the groove damage for asphalt mixtures using PMA II and PMA III, there was no difference in percentage reduction, regardless of test temperature.

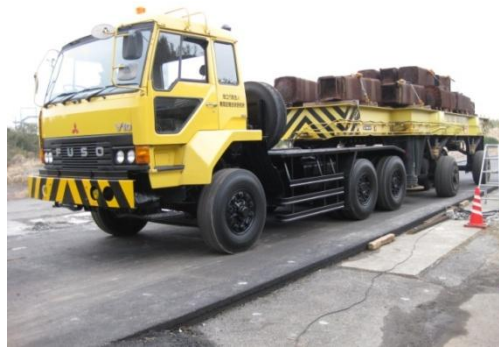
Fig. 6. Prototype traveling load vehicle.

In order to confirm the test results in laboratory in the field, repeated loading tests were carried out using full-scale wheels in an outdoor test field. This test was not carried out to evaluate the curing effect, but to evaluate the impact of materials and load temperature on the test results. The tests were carried out during the winter (middle of February) and the summer (beginning of September) to take into account the effect of pavement temperature. The temperature conditions in the tests are shown in Table 3. Figure 5 shows a cross-section of the pavement used in the tests. A binder course and a surface course were constructed on an existing asphalt pavement. Asphalt mixtures using straight asphalt 60/80, PMA II, and PMA III were used in the surface course, the same as for the laboratory tests. In the laboratory tests, there was no difference between the amount of groove damage for the asphalt mixtures using PMA II and PMA III. So, in the outdoor tests, tests for the asphalt mixtures using PMA III were carried out only during the winter. The grooving was carried out over a 3.0m area in the surface course of each asphalt mixture. The grooves were a shape commonly used in airport pavements as shown in Fig. 2. The prototype traveling load vehicle shown in Fig. 6 was used in the full-scale wheel repeated loading tests. The vehicle was a loading device that simulated one set of wheels of an aircraft, pulled by a trailer, with ingots loaded on the top of the loading device to adjust the axle loads. In these tests the axle load was adjusted to obtain a contact pressure of 1.5MPa equivalent to a large aircraft such as the Airbus A380-800. Also, the target wheel traveling speed was about 7.5km/h, taking into consideration the trailer performance and safety during the tests. Figure 7 shows the full-scale wheel loading at the surface with grooving. The maximum number of load repetition was 720, and the groove damage was evaluated from the percentage reduction of the groove at 0, 30, 60, 120, 240, 360, 480 and 720 load repetitions. The definition of the percentage reduction was the same as for the laboratory tests. The groove width and depth were measured using a laser displacement meter. Also, since the asphalt mixtures significantly chipped off during loading, “the scattered asphalt mixtures” were collected over a length of 3.0m and width 1.9m in the areas where the grooves were cut, and its mass was measured. For measurement of the groove width and depth, six positions were selected in an area 30×30cm from the loading wheel traveling position, and five measurement lines were set up in each of these areas. The average groove width and depth on these five measurement lines was obtained, and the results for the six areas were averaged.

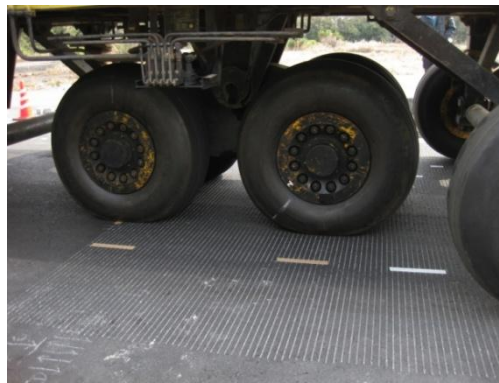
Fig. 7. Full-scale wheel loading at the surface with grooving.

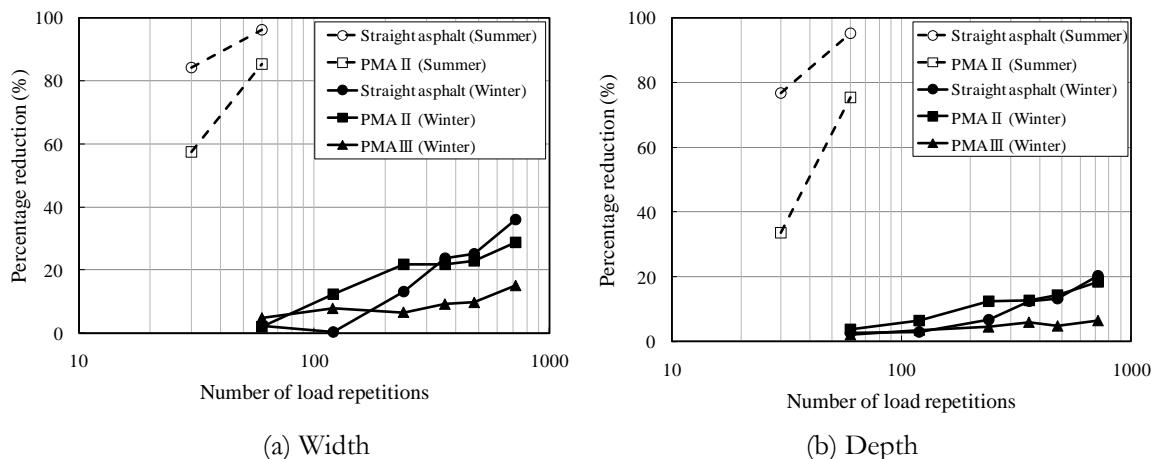
Fig. 8. Percentage reduction of the grooves.

Figure 8 shows the relationship between the number of load repetitions and the groove percentage reduction. Looking at the results for winter and summer, there is a distinct effect of test temperature. In the winter test results, the amount of groove damage was small for all the asphalt mixtures used. There was little difference between the groove percentage reduction for the asphalt mixtures using straight asphalt and PMA II. On the other hand, the groove damage was reduced by using asphalt mixtures that use PMA III. In the summer test results, there were significant changes in the groove. The groove percentage reduction for the asphalt mixtures using PMA II was significantly smaller compared with the asphalt mixtures using straight asphalt. From the above, even when the loads are equivalent to those of large aircraft, it can be concluded that it is possible to reduce the actual groove damage on site by using asphalt mixtures that use modified asphalt compared with the case where asphalt mixtures using straight asphalt.

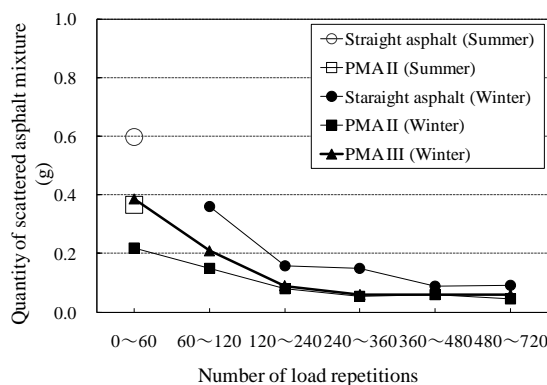
Fig. 9. Quantity of scattered asphalt mixture.

The failure modes also changed with temperature. Figure 9 shows the results for measurement of the quantity of scattered asphalt mixture. In the winter tests, the quantity of scattered asphalt mixture was greatest in the order straight asphalt, PMA III, and PMA II. Many fragments were seen in all the asphalt mixtures in the initial loading stage. Especially, fine fragments were seen only in the straight asphalt mixture. As the number of load repetitions increased, larger particle size fragments were found in all the asphalt mixtures. In the summer tests, the quantity of scattered material was significantly larger for straight asphalt. This result is the same trend as in the winter tests. Relatively large particle size fragments were found in all the asphalt mixtures from the initial loading stage. Figure 10 shows the observed failure mode of asphalts. In the winter tests, the temperature near the pavement surface was around 10°C, so the asphalt viscosity effect was considered to be small. In the case of modified asphalt, the resistance to the load was high, so the squeezed asphalt was not pulverized (Fig. 10(a)). On the other hand, for the straight asphalt, the squeezed asphalt was pulverized by the loading (Fig. 10(a)), so the fine fragments were produced. In this case, with this measurement system for measuring the width and depth, the width were found to be greater for the straight asphalt compared with the modified asphalt, because the squeezed asphalt was pulverized. This can explain the results for the groove percentage reduction shown in Fig. 9. In the summer tests, the protruding parts of the groove were crushed in a mode that resembled compressive failure of short column in all the asphalt mixtures (Fig. 10(b)). It seems that this failure mode was observed when the pavement temperature is high. These observations were made from the results of groove deformation in the laboratory tests and the in-situ tests. In the future it is necessary to study the failure mechanisms and their effect on the traveling safety of aircraft.
