Article

Experimental Investigation of the Fire Resistance of Thin Hollow-Core Concrete Slabs with Simple Supports

ENGINEERING JOURNAL Volume 19 Issue 2

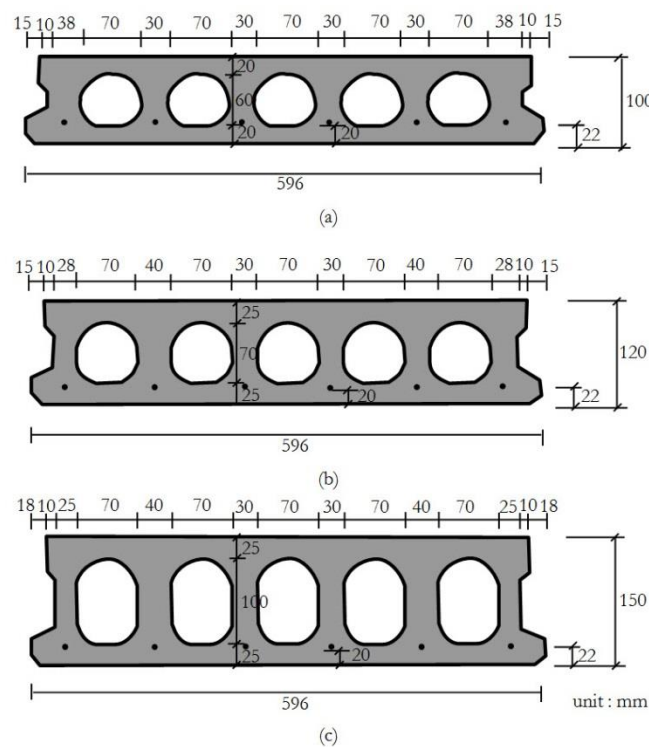
Fig. 1. Cross sections of hollow-core concrete slabs with different thicknesses: (a) 100 mm; (b) 120 mm; (c) 150 mm.

Three values of thickness were examined, i.e. 100 mm, 120 mm and 150 mm, respectively. The nominal concrete strength for the specimens was specified as 35 MPa at 28 days. Each of the hollow-core concrete slabs was reinforced with six 4 mm-diameter prestressing steel wires with a fixed concrete cover of 20 mm. The ultimate tensile strength of the prestressing steel was 1850 MPa. The cross sections of the test specimens are illustrated in Fig. 1.

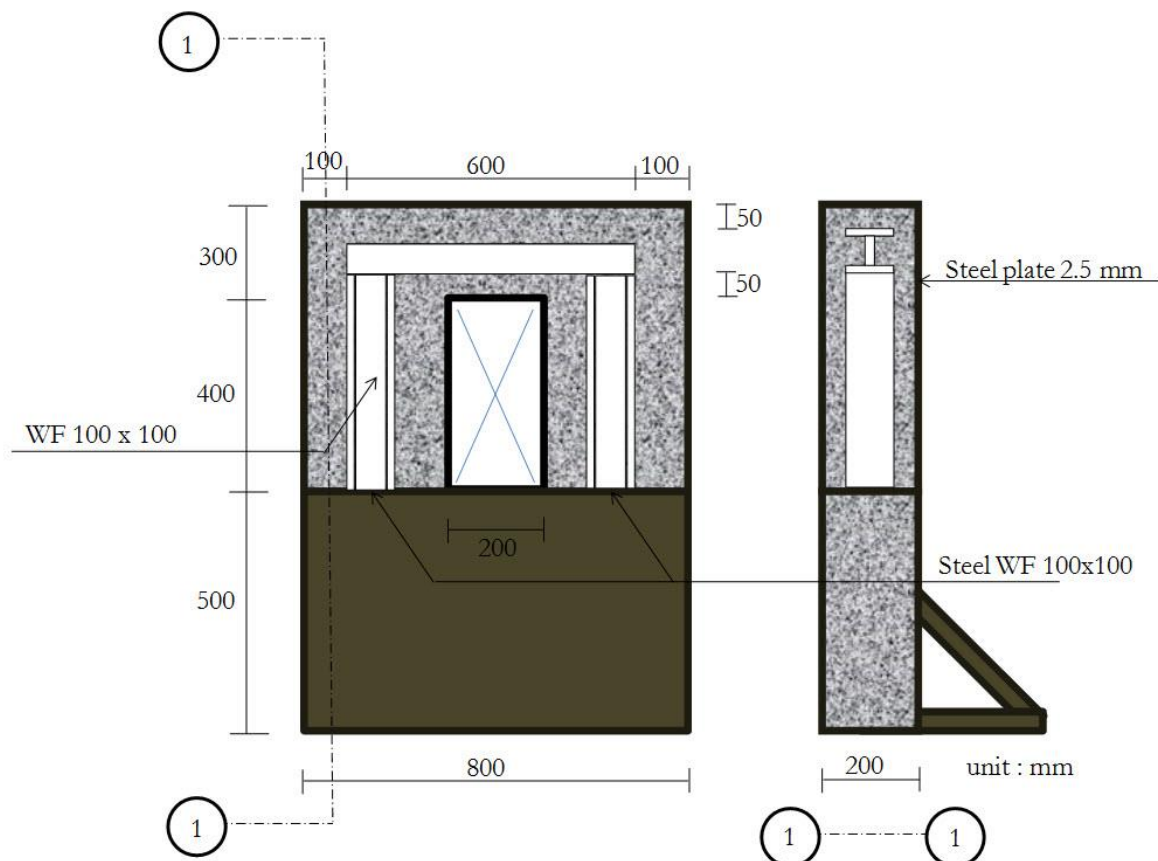
Fig. 3. Support of the test specimen with ventilation opening.

All of the specimens were installed inside the furnace chamber as simply supported one-way slabs on two steel-concrete composite blocks. The seating dimensions of each specimen at both ends on the supports were specified as 200 mm to simulate the actual conditions of hollow-core concrete slab installation in practice. The details of the composite support are shown in Fig. 3. Note that one of the supports was manufactured with a 200 mm x 500 mm opening to accommodate hot air exhaust outflow from the furnace chamber.

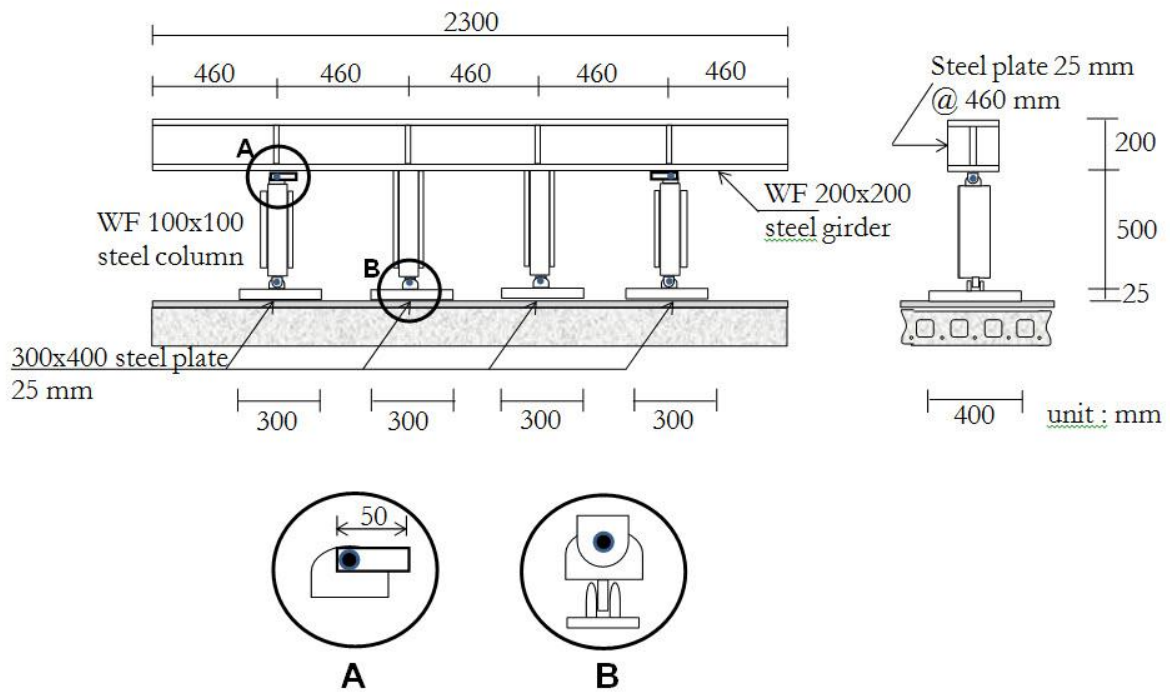
Fig. 4. Details of the loading frame.

Prior to heating up the furnace chamber, each specimen was subjected to a uniformly distributed load as determined by the specified load ratio. The load was initially applied as a point load by means of a hydraulic jack with 300-kN capacity. The applied load was transferred to the specimen using a mechanical device as shown in Fig. 4. Note that the contact points between the loading device and the specimen were allowed to rotate freely in longitudinal direction to accommodate the vertical deflection of the specimen during the fire test.

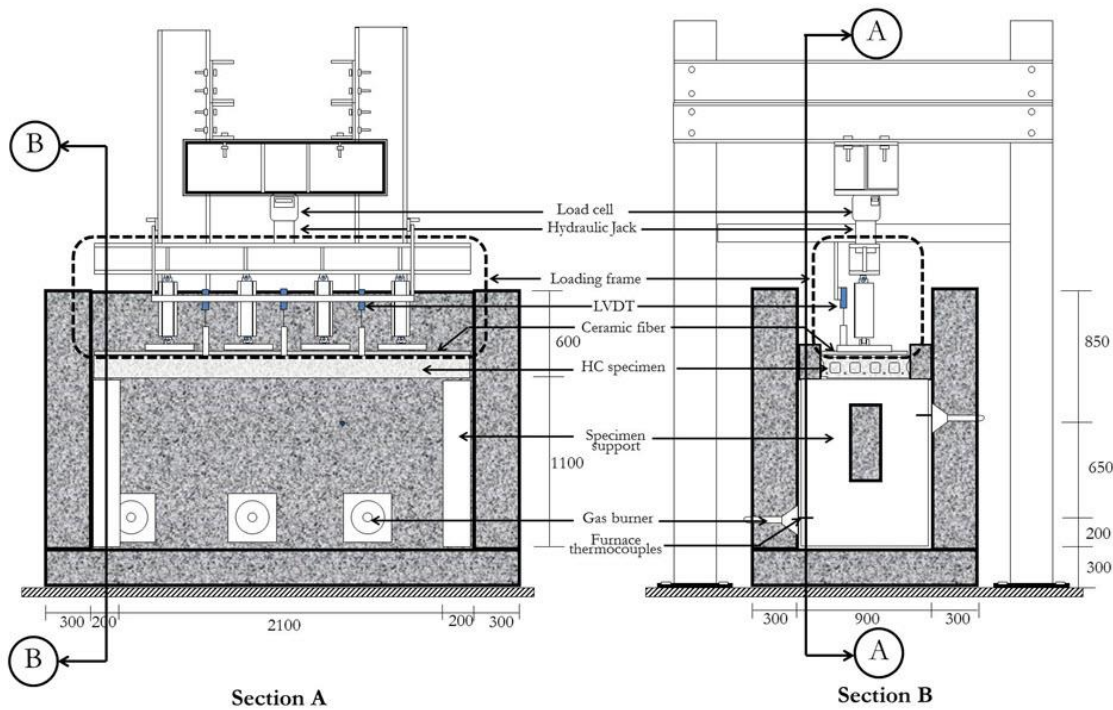
Fig. 5. Overview of the experimental setup.

To maintain a constant level of loading with respect to the specified load ratio, a load cell was installed between the hydraulic jack and the mechanical device. Figure 5 illustrates the overview of the test setup for the fire tests.

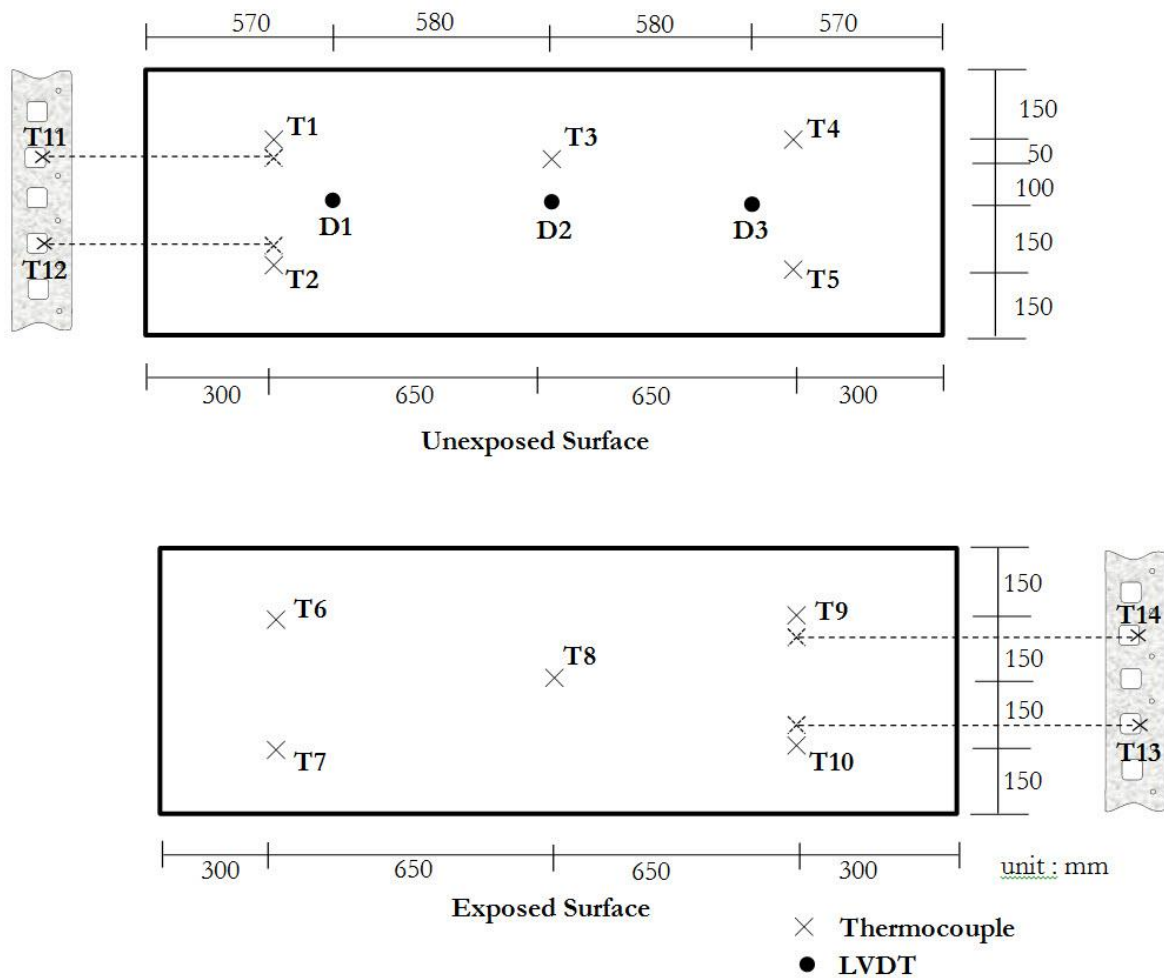
Fig. 6. Locations of thermocouples and LVDTs on the test specimen.

The temperatures of the hollow-core concrete slabs were measured during the fire test using type-K thermocouples wires installed at fourteen different locations as shown in Fig. 6. The temperature data were recorded and collected through the Kyowa EDX-100A4H data acquisition system.

The vertical deflections of each hollow-core concrete slab were also recorded during the heating period using three linear variable differential transducers (LVDTs) with a measurement range of ± 200 mm at mid-span and quarter-span as also shown in Fig. 6.

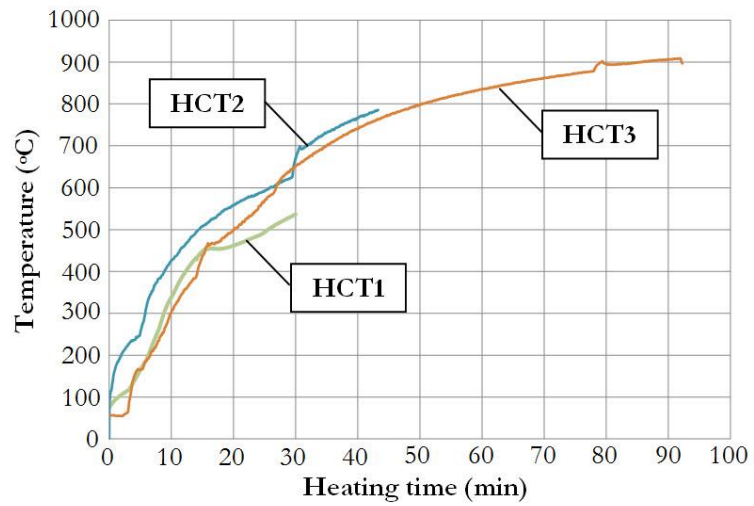
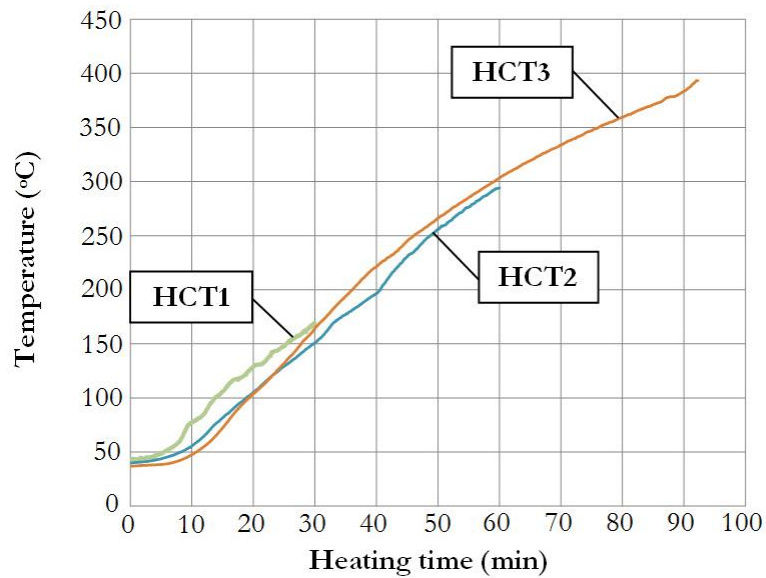
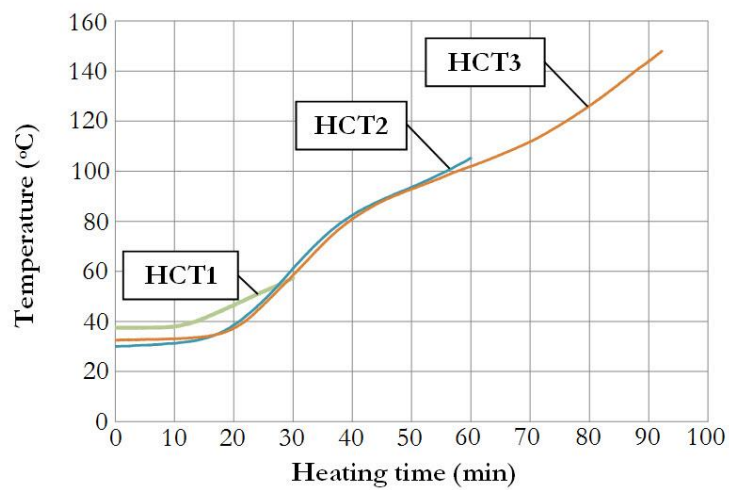
Fig. 7. Temperature vs. time for HCT1–HCT3: (a) exposed surface (b) hollow core (c) unexposed surface.

The test results for HCT1 – HCT3 are summarized in Table 2. The measured temperatures and vertical deflections of the specimens during the fire tests are plotted in Fig. 7 and Fig. 8, respectively.

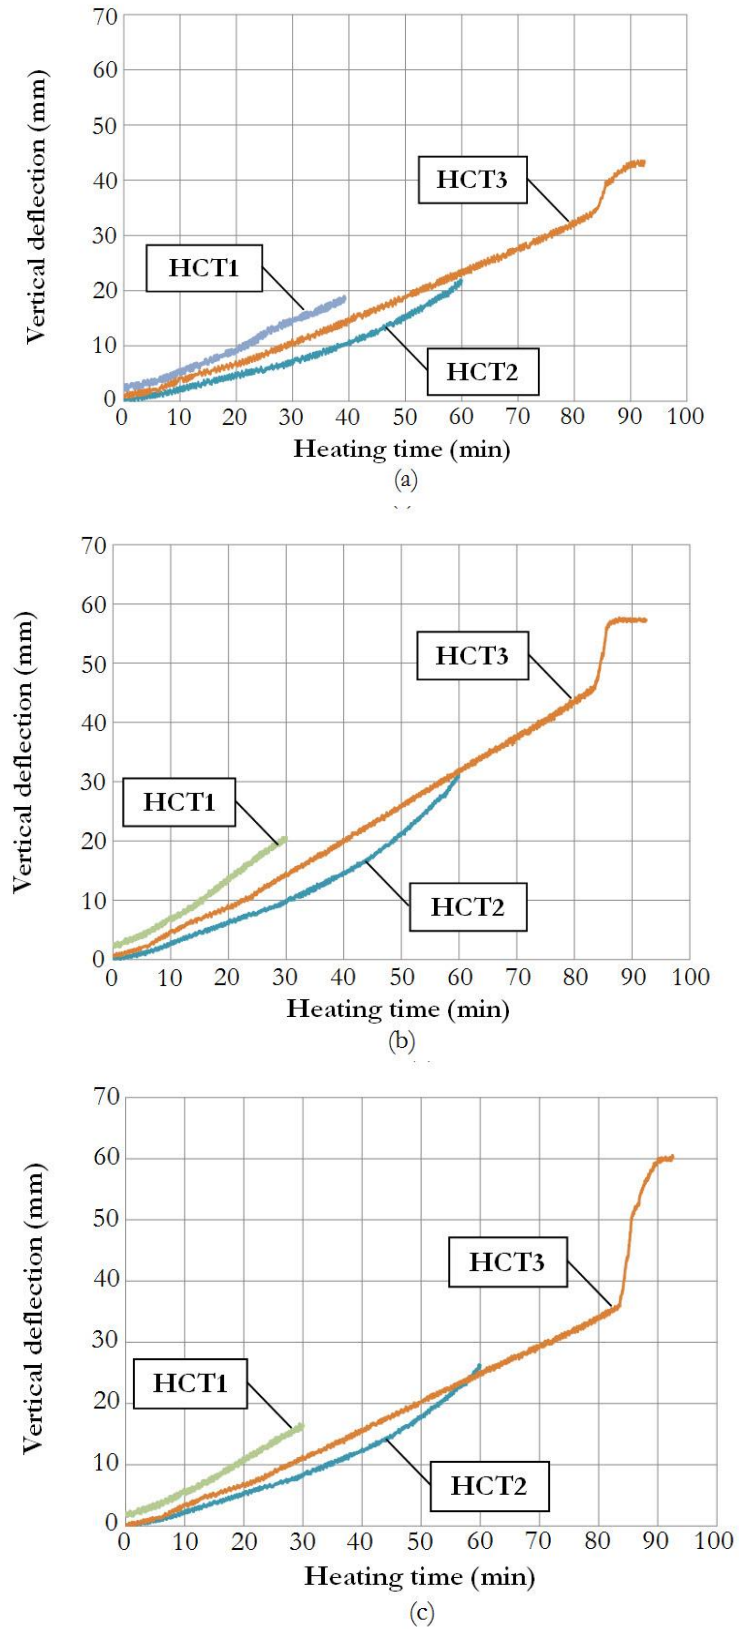
Fig. 8. Vertical deflection vs. time for HCT1 – HCT3: (a) 1st quarter (b) mid-span (c) 3rd quarter.

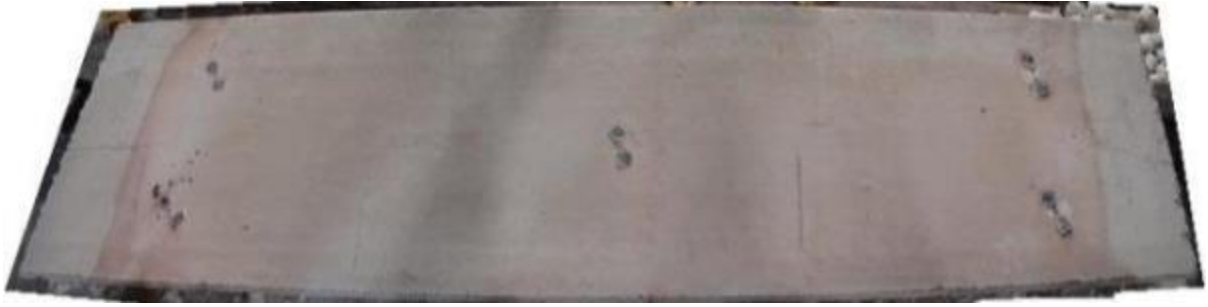
Fig. 9. HCT1 after fire test.

HCT1 was subjected to the applied load ratio of 0.3. During the 30-min heating period, the average temperature of the exposed surface reached 712°C. The temperature gradients between the exposed and unexposed surfaces and between the exposed surface and hollow core after 30 min were 662°C and 568°C, respectively. The maximum vertical deflection of the specimen was 23.7 mm at mid-span after the 30-min heat exposure. The slab remained intact without collapse. No concrete spalling was observed on the exposed surface of the specimen as shown in Fig. 9.

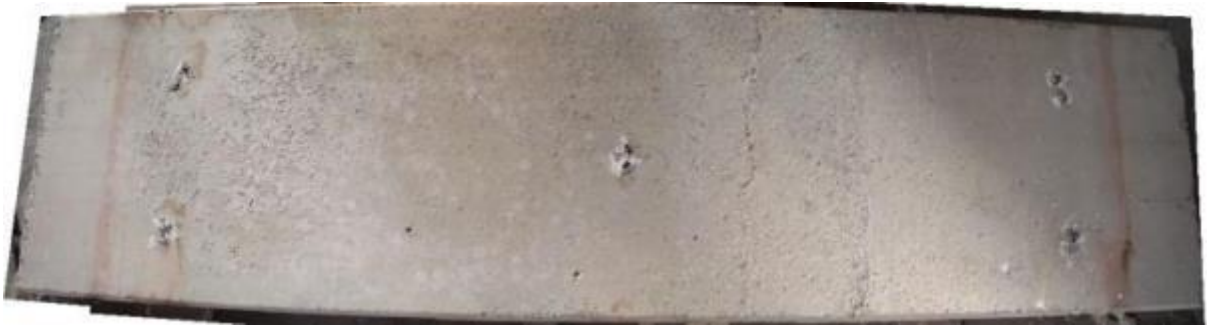
Fig. 10. HCT2 after fire test.

HCT2 was also subjected to the applied load ratio of 0.3 as HCT1 but was heated for 60 min. After the 60-min heating period, the maximum vertical deflection recorded at mid-span was 31.4 mm while the average temperature of the exposed surface was 867°C. The temperature gradients between the exposed and unexposed surfaces and between the exposed surface and hollow core after 60 min were 762°C and 573°C, respectively. The post-fire investigation of HCT2 revealed that 77% of the exposed surface area was subject to concrete spalling with an average depth of 2 mm. In addition, a transverse crack was observed near mid-span as shown in Fig. 10. However, the specimen did not collapse during the fire test.

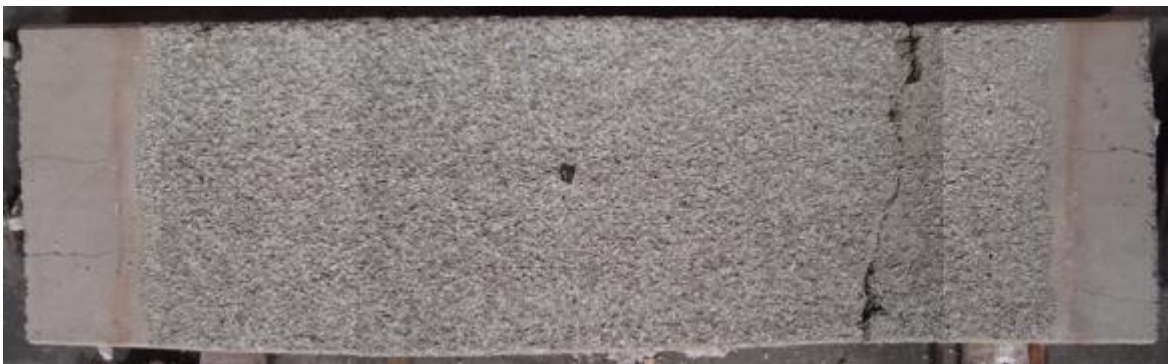
Fig. 11. HCT3 after fire test.

For HCT3 the heating duration was specified as 90 min. However, the specimen collapsed after 82 min of heat exposure based on the rate of deflection criterion of ISO 834-1. The maximum deflection recorded at mid-span was 57.5 mm and the average temperature of the exposed surface reached 907°C after the 82-min heating period. The temperature gradients between the exposed and unexposed surfaces and between the exposed surface and hollow core after 82 min were 759°C and 514°C, respectively. The post-fire investigation revealed a transverse crack on the exposed surface near the support as shown in Fig. 11. Furthermore, the entire exposed surface area of the specimen was subject to concrete spalling with an average depth of 10 mm.

Based on the test results, it can be concluded that the level of concrete spalling increases with the heating duration. However, concrete spalling may not be a crucial factor to the failure of the specimen since the maximum depth of concrete spalling for HCT3 is less than the concrete cover. The failure of HCT3 is observed to be due to the occurrence of a transverse crack after 82 min of standard fire exposure.

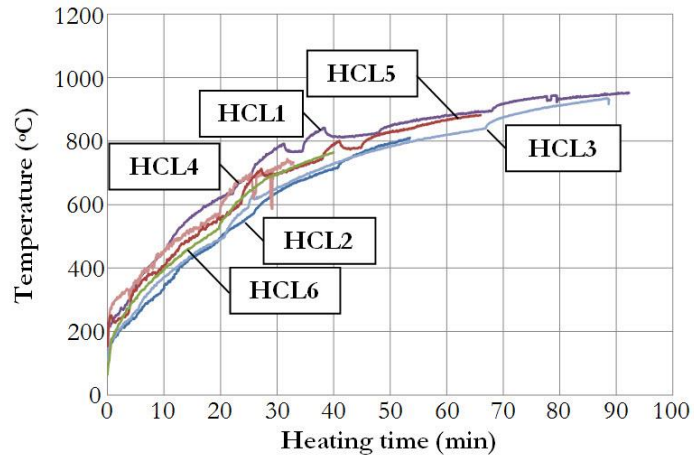
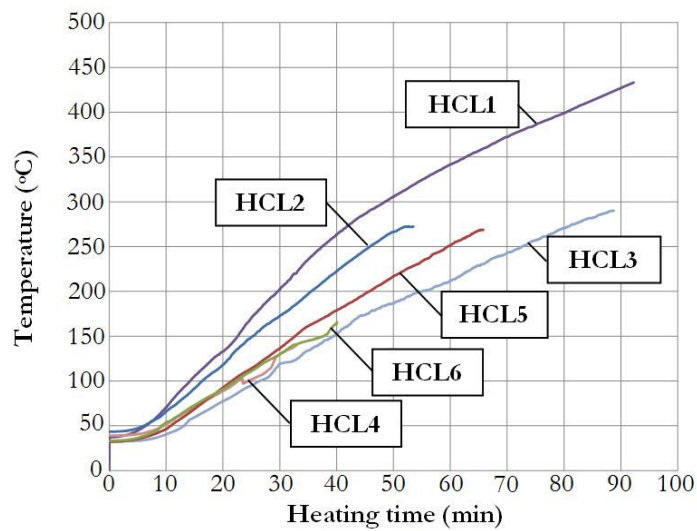
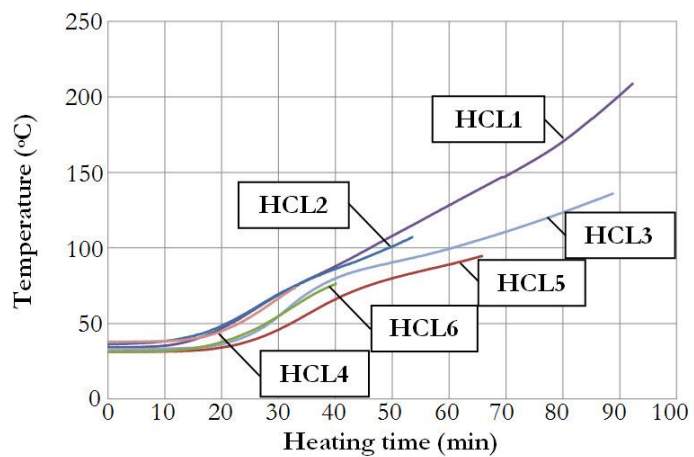
Fig. 12. Temperature vs. time for HCL1 – HCL6: (a) exposed surface (b) hollow core (c) unexposed surface.

The heating duration for HCL1 – HCL6 was specified as the time until failure of each specimen, and is reported as the fire-resistance rating (FRR) as summarized in Table 3. The temperatures and vertical deflections of the specimens recorded during the fire tests are illustrated in Fig. 12 and Fig. 13, respectively.

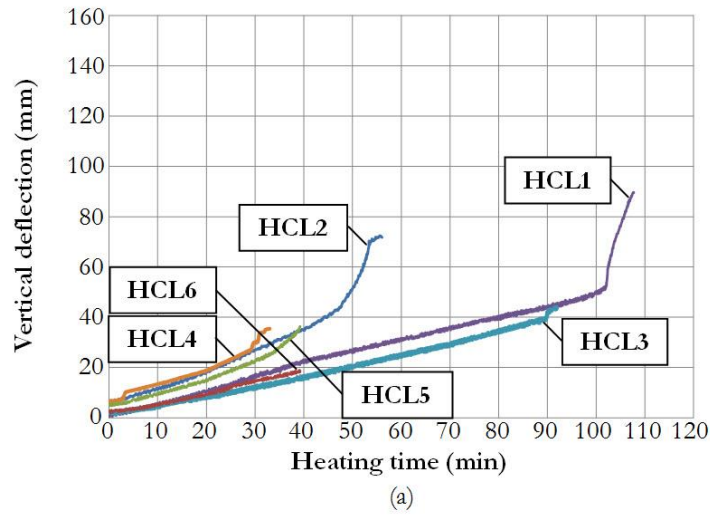
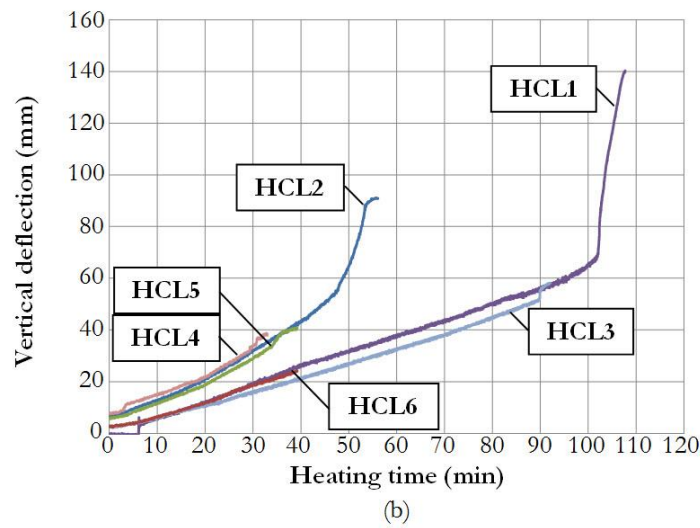
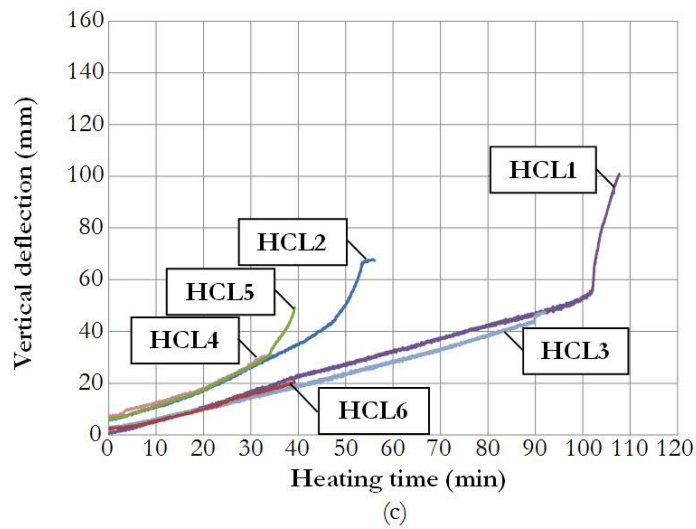
Fig. 13. Vertical deflection vs. time for HCL1 – HCL6: (a) 1st quarter (b) mid-span (c) 3rd quarter.

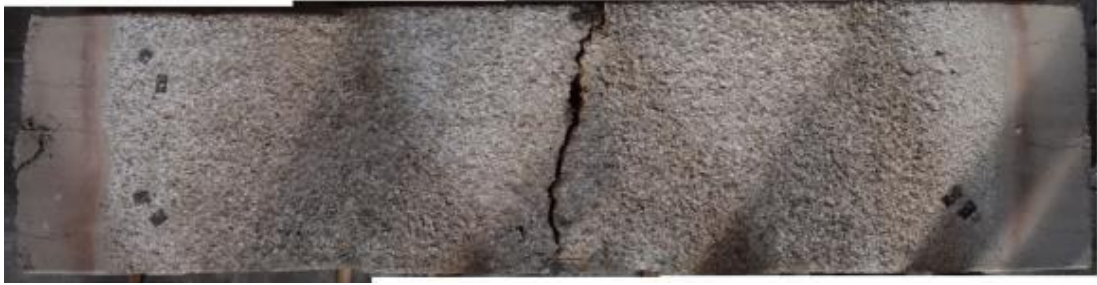
Fig. 14. HCL1 after fire test.

mid-span was 140.3 mm and the average temperature of the exposed surface was 963°C at the time of failure. The temperature gradients between the exposed and unexposed surfaces and between the exposed surface and hollow core after 107 min were 719°C and 503°C, respectively. From the post-fire examination, it was found that concrete spalling occurred over the entire exposed area with an average depth of 10 mm and a maximum depth of 15 mm. A large transverse crack was also observed near mid-span as shown in Fig. 14.

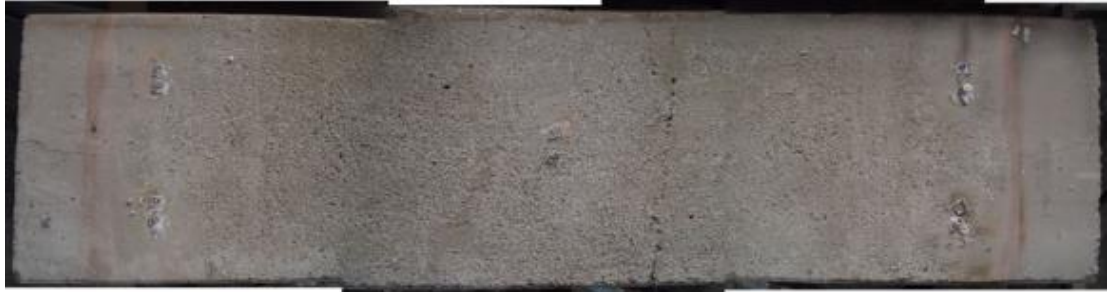
Fig. 15. HCL2 after fire test.

HCL2 had the same thickness as HCL1 (100 mm) but was subjected to a higher load ratio of 0.6. The FRR of the specimen was 53 min based on the rate of deflection criterion with a maximum vertical deflection recorded at mid-span of 91 mm, which was smaller compared with HCL1. The average temperature of the exposed surface reached 812°C at the time of failure. The temperature gradients between the exposed and unexposed surfaces and between the exposed surface and hollow core after the 53-min heating period were 704°C and 539°C, respectively. Despite a higher load ratio compared with HCL1, concrete spalling was observed on only 84% of the exposed area with an average depth of 3 mm and a maximum depth of 5 mm. In terms of concrete spalling, the severity of damage was much lower compared with HCL1. Nevertheless, the post-fire investigation revealed a transverse crack near mid-span on the exposed surface as shown in Fig. 15.

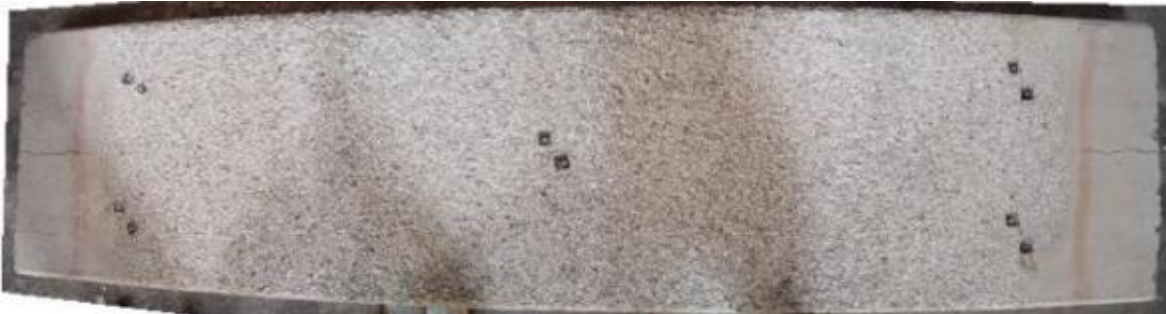
Fig. 16. HCL3 after fire test.

The thickness of HCL3 was 120 mm and the load ratio was specified as 0.3. The test results can be cross checked with HCT3. It was found that the FRR of HCL3 was 91 min based on the rate of deflection criterion. The FRR of HCL3 is a bit higher compared with HCT3 at 82 min. The average temperature of the exposed surface reached 930°C at the time of failure. The temperature gradients between the exposed and unexposed surfaces and between the exposed surface and hollow core after the 91-min heating period were 813°C and 640°C, respectively. The maximum vertical deflection recorded at mid-span was 58.1 mm. Even though the entire exposed area of the specimen was subject to concrete spalling with an average depth of 7.5 mm and a maximum depth of 10 mm, no evidence of transverse crack was observed after the fire test as can be seen in Fig. 16.

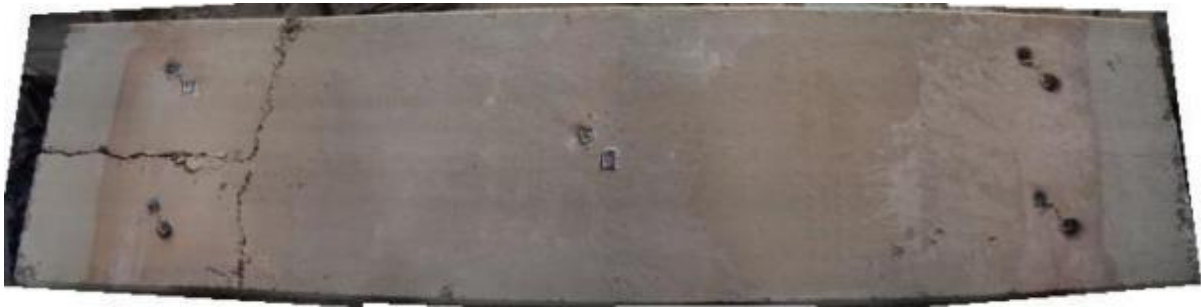
Fig. 17. HCL4 after fire test.

The thickness of HCL4 was the same as HCL3 but the load ratio was higher at 0.6. The FRR of the specimen was 33 min based on the rate of deflection criterion. After the 33-min heating period, the maximum vertical deflection recorded at mid-span was 38.8 mm and the average temperature of the exposed surface was 744°C. The temperature gradients between the exposed and unexposed surfaces and between the exposed surface and hollow core after the 33-min heating period were 673°C and 608°C, respectively. Interestingly, virtually no concrete spalling was observed on the exposed surface of the specimen after the fire test. However, a severe transverse crack was observed near the support as shown in Fig. 17. Note that the longitudinal crack at the support was an extraneous damage as a result of hoisting the specimen which occurred after the fire test.

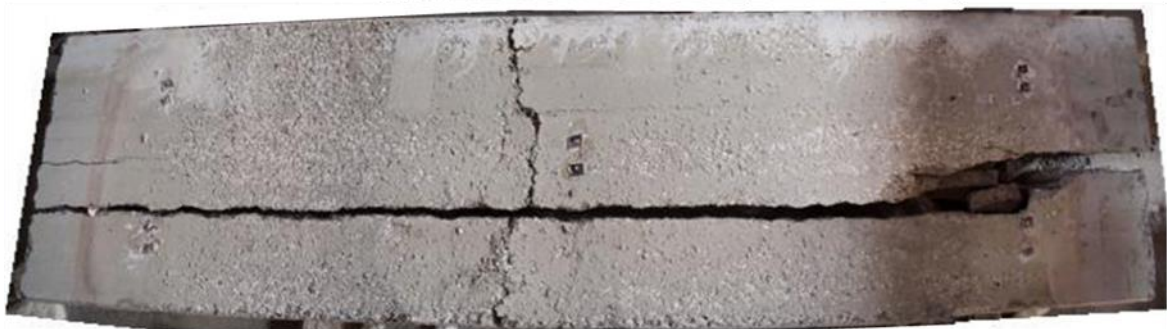
Fig. 18. HCL5 after fire test.

The thickness of HCL5 was 150 mm, while the load ratio was specified as 0.3. The FRR of the specimen was 66 min based on the rate of deflection criterion. The maximum vertical deflection recorded after the 66-min heating duration was 51.2 mm, which occurred at the first quarter. The average temperature of the exposed surface of the specimen was 882°C at the time of failure. The temperature gradients between the exposed and unexposed surfaces and between the exposed surface and hollow core after the 66-min heating period were 788°C and 614°C, respectively. Based on the post-fire examination, a transverse crack was observed near mid-span on the exposed surface while the longitudinal crack was an extraneous damage as a result of hoisting the specimen which occurred after the fire test. Concrete spalling was observed over 85% of the exposed surface area with an average depth of 2.5 mm and a maximum depth of 7.5 mm. Fig. 18 illustrates HCL5 after the fire test.

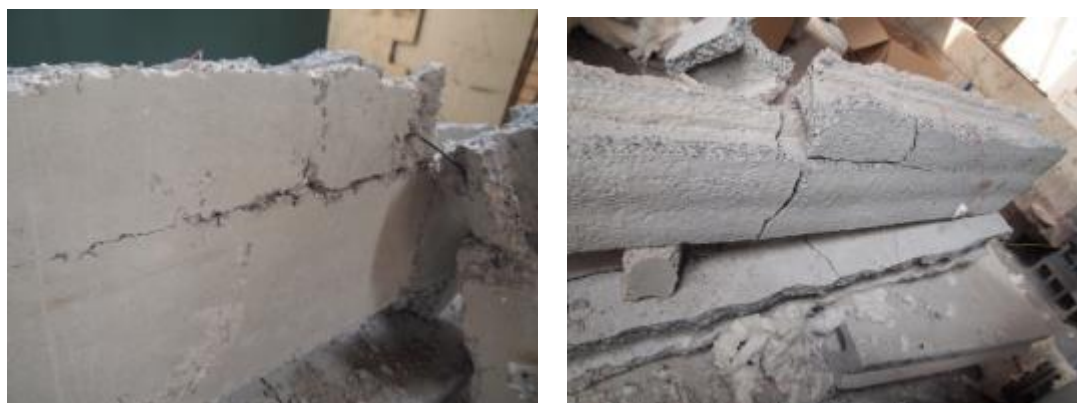
Fig. 19. HCL6 after fire test.

HCL6 had the same thickness as HCL5 but was subjected to a higher load ratio at 0.6. Surprisingly, the specimen abruptly collapsed after only 39 min of heat exposure without any significant warning. Fig. 19 illustrates the remaining HCL6 after failure. No significant measurements could be taken due to the brittle failure. The average temperature of the exposed surface prior to failure was 764°C while the maximum vertical deflection recorded at mid-span was 40.7 mm. The temperature gradients between the exposed and unexposed surfaces and between the exposed surface and hollow core prior to failure were 688°C and 600°C, respectively. The post-fire investigation of damage revealed tendon rupture as well as transverse and longitudinal cracks on the exposed surface. Longitudinal cracks were also observed along the web of the hollow cores.
